# Forensic Fire Consultants, Ltd.

Re: Proposed WestWing Transfer Station Site  
Hazard Mitigation Analysis & Fire Risk Study

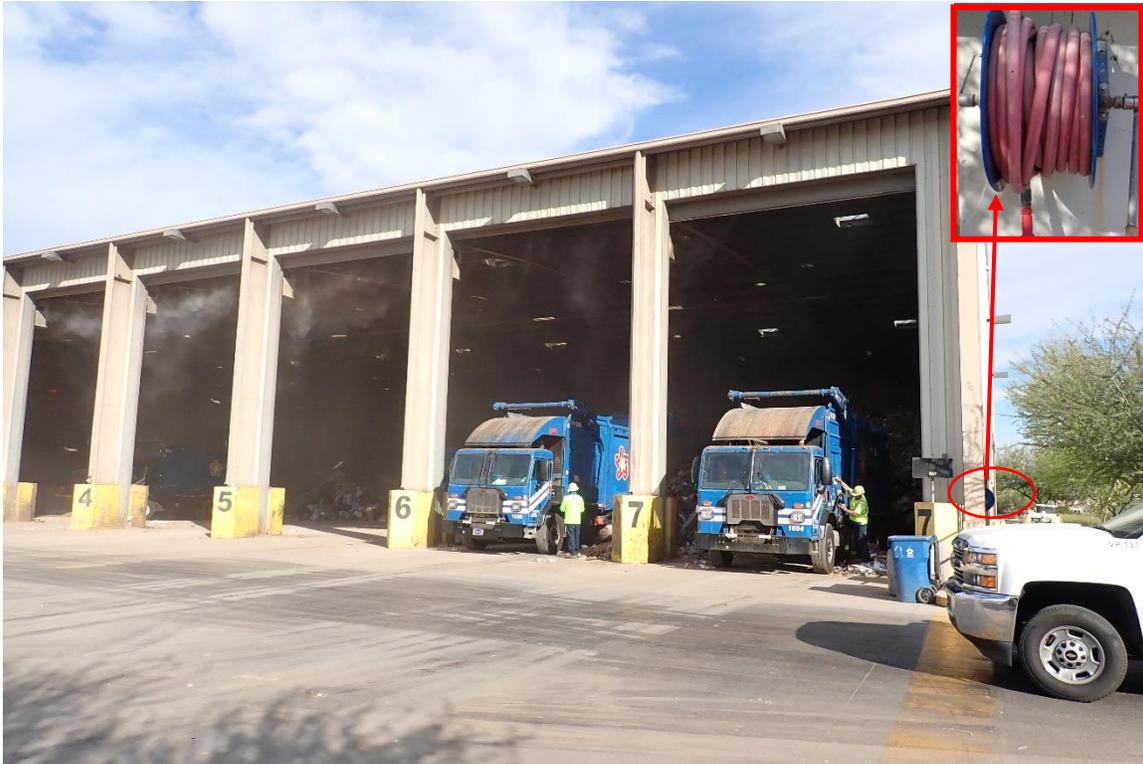
Cave Creek site with five of the seven bays, misting system on-1" fire hose circled in red

The inspected site is larger than the WWTS yet the operational and movement of material and equipment would be similar. The structure, like the WWTS, was constructed of non-combustible material with a high ceiling (passive fire protection). It was equipped with a fire suppression system (active fire protection) as well as required extinguishers. A 1" diameter hose reel was mounted within close proximity to the load out area for use in rapid fire suppression of materials segregated from the pile by the trained equipment operator. The moisture control system was fully operational which is not only primarily for odor control, but also creates a higher Relative Humidity (RH) which aids in keeping the combustibility of waste products low. The interior tipping floor is monitored 24/7 by the Republic Services Operations Center (RSOC) in

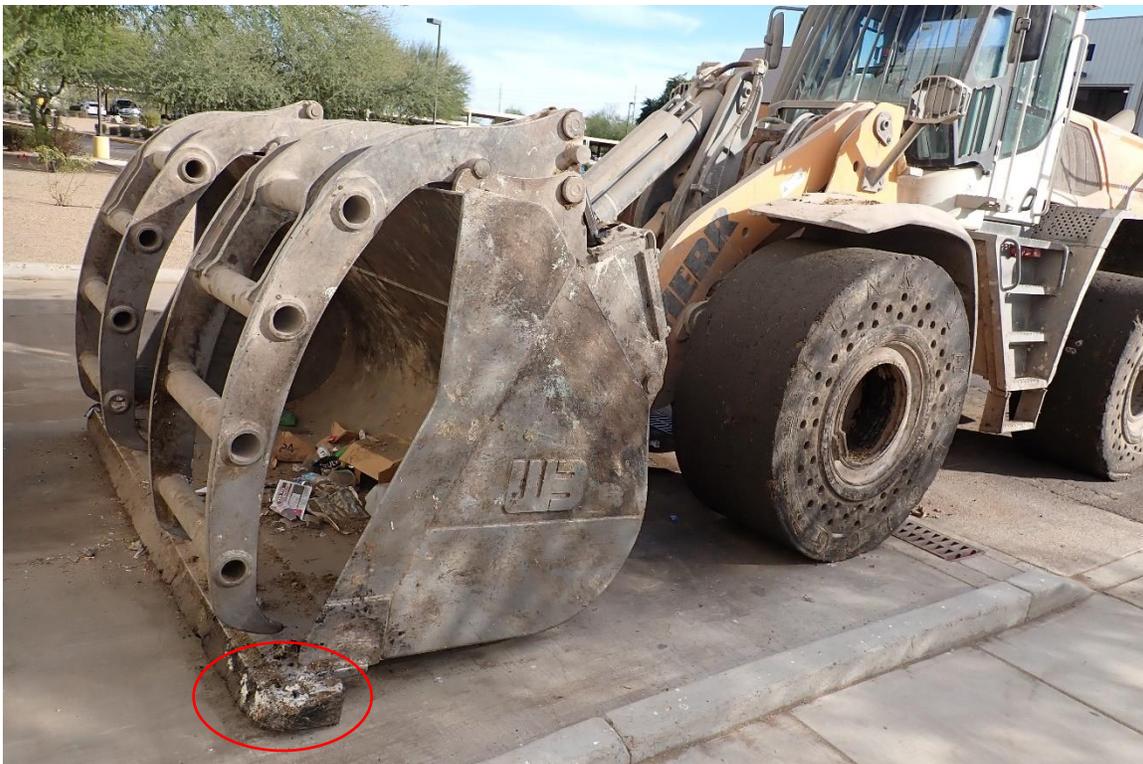
Front end loader with rubber tires and rubber "squeegee" on blade-circled in red

- v. Non-spark producing equipment, such as rubber tires and rubber “squeegee” on the bucket of tractor
  - b. Fire detection
    - i. On-site personnel
    - ii. Audio and video communications with on-site *and* off-site personnel

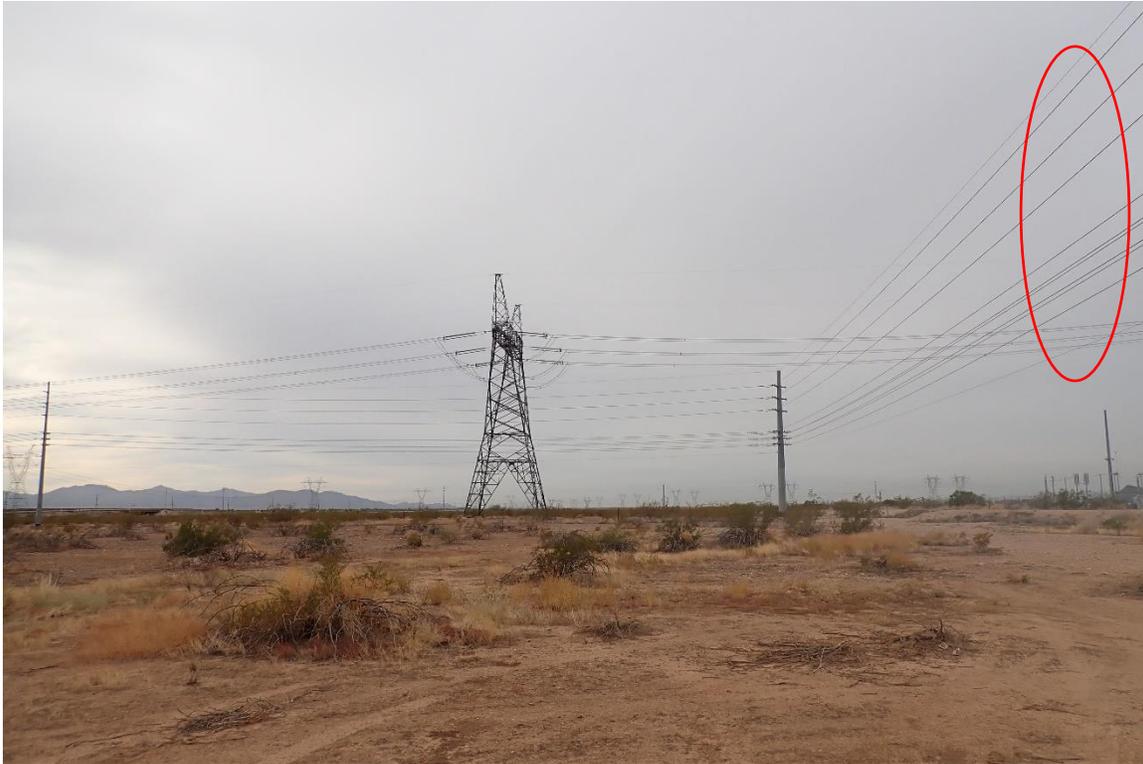
View looking west from proposed site with electric lines on north property line-in red

Of note, the north facing opening of the structure would have five bays. In the unlikely event a large-scale fire ensued, the closest overhead electric utility lines are located over 175' due north along an APS easement. The second closest overhead electric utility lines are over 250' due west. These dimensions are from the proposed facility and not the property line.

Numerous power poles, energized electrical lines, towers and other electrical sub-station components are within a visible area from the site. The sub-station and the grounds surrounding the energized lines is generally well-kept and free of weeds and vegetation.

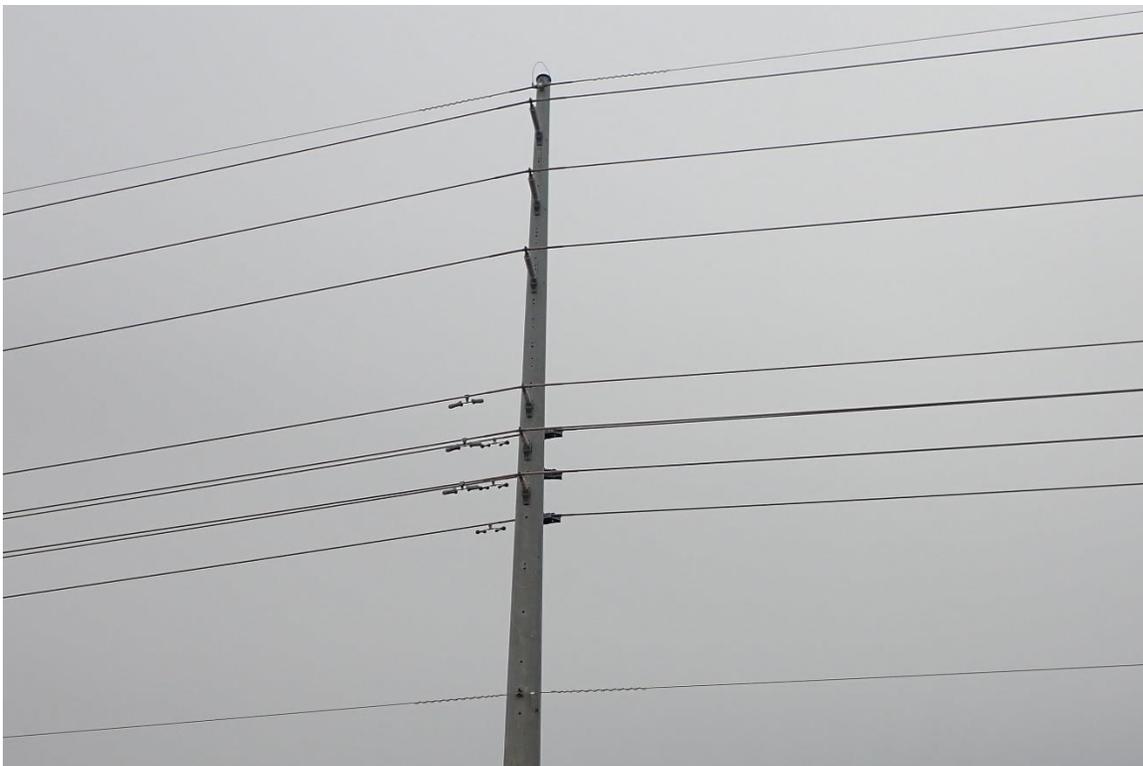
Closer detail of pole approximately 175' north of proposed structure

In extremely rare instances involving wildland fires, the dense vegetation below or adjacent energized electric lines can generate thick smoke with a high carbon content causing the electricity to find a path to earth or the metal tower/pole. This rare phenomenon can also be achieved with the burning of tires or heavy plastics, commonly observed in dense commercial processing facilities. The comparison of heavy fuels such as dense vegetation, rubber tires, and plastic to the lighter fuels of household waste accumulation would infer the carbon content could not be sufficient to facilitate the transfer of electrical current or failure of the energized lines. Additionally, the smoke and heat dissipation over the span of 175'/250' would further erode the potential for thermal decay of the electrical lines.
